**28 Goldfinch Ct,
Greenbank QLD 4124,
Australia**

Roof Information - Default - Main Roof

Damage Assessment - Default - Main Roof

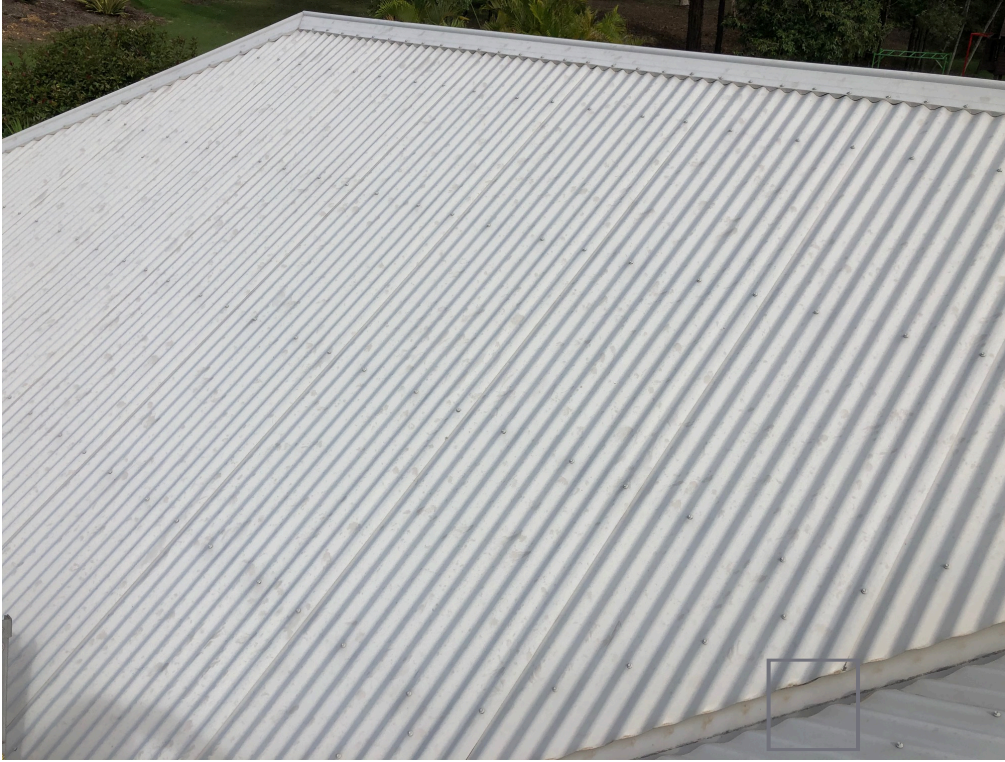
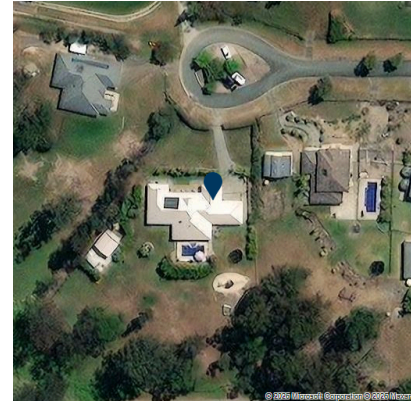
Lat: -27.7444028
 Lon: 152.9176778

● Defective Fixing Installation 1

● Defective Fixing Installation

defect

Description: Fixings may be under- or over-tightened, misaligned, or incorrectly positioned. These defects can compromise waterproofing, reduce wind resistance, and lead to sheet movement or corrosion.

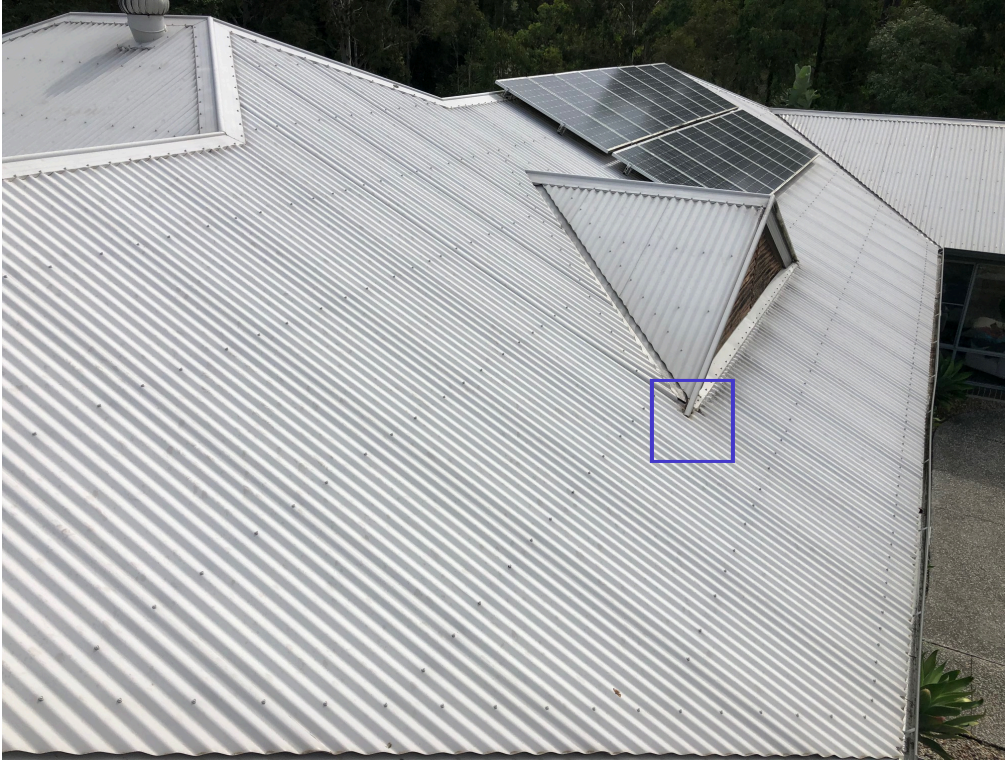
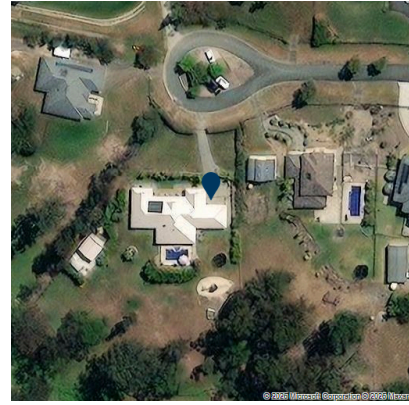
Lat: -27.7443917
 Lon: 152.917725

● Defective Flashing Joint 1

● Defective Flashing Joint

defect

Description: Flashing joints that are poorly sealed, misaligned, or separated can allow water ingress at critical roof intersections. This can lead to internal leaks, corrosion, and accelerated material degradation.

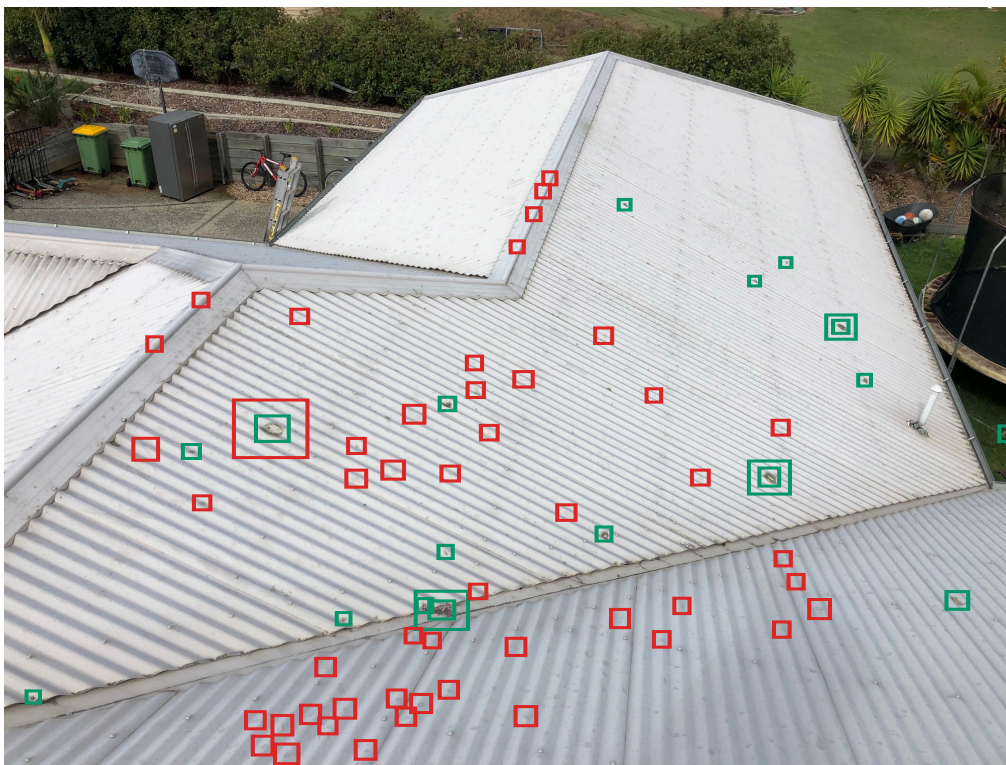
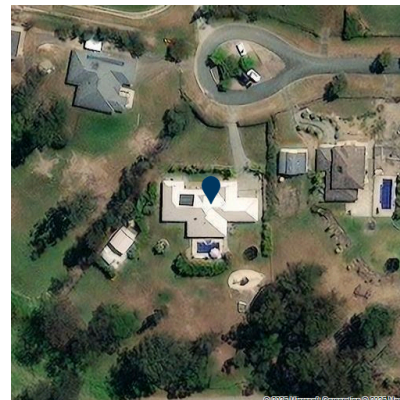
Lat: -27.744425
 Lon: 152.9176167

● Lichen 20
● Hail Hit 49

● **Lichen**

maintenance

Description: Lichen forms when algae and fungus combine on your roof, often brought by tree debris and organic matter. It traps moisture, accelerating wear and tear. As it latches onto the roof, cleaning it becomes challenging and can lead to damage over time.

● **Hail Hit**

insurable

Description: Hails Hits have caused dents in roof & or sheet metal sheeting that can affect the structural integrity of the material depending on the size, location, and severity of the dent.

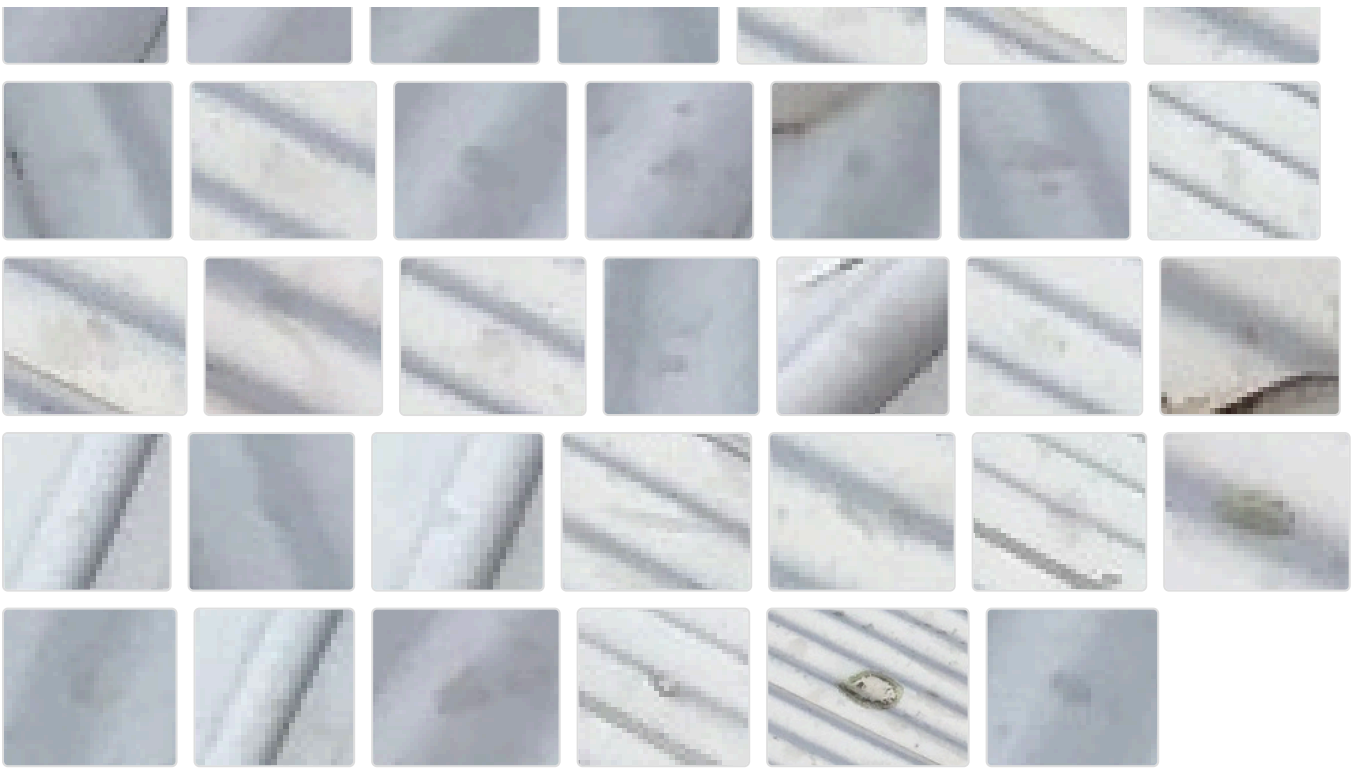
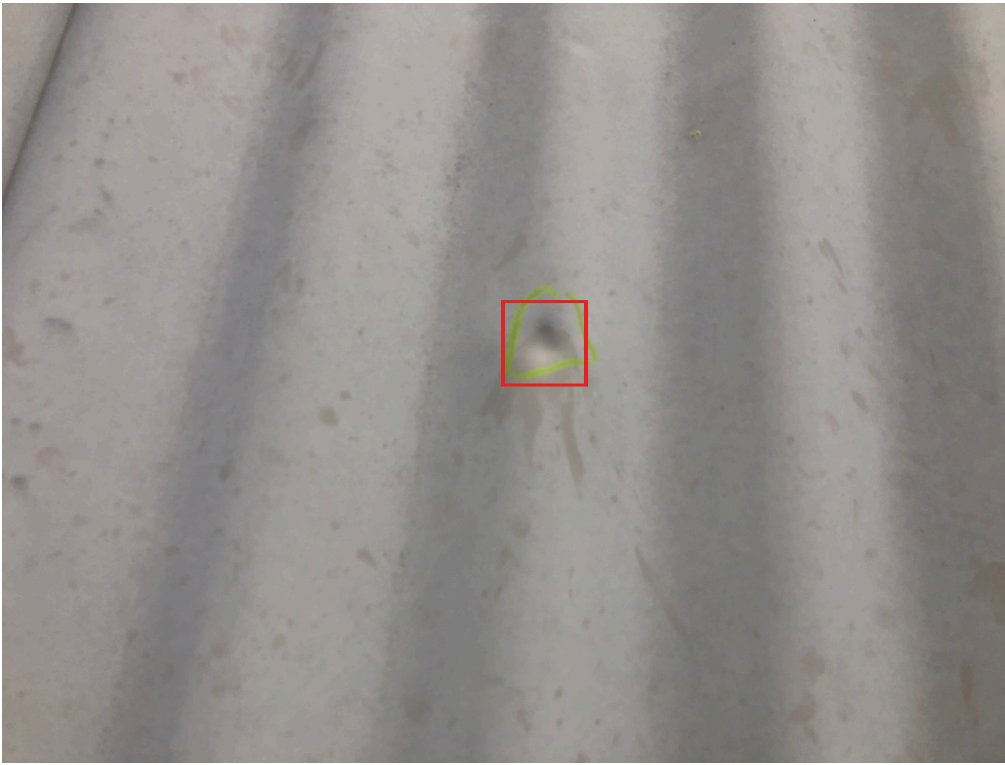
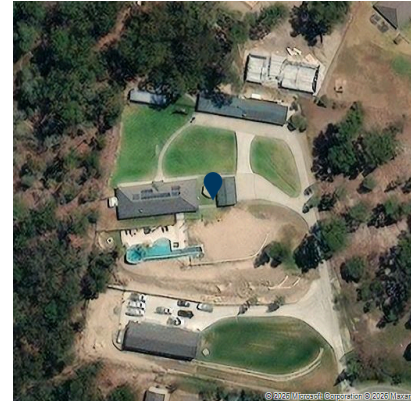
Lat: -27.7444487
Lon: 152.9175834

● Hail Hit 1

● Hail Hit

insurable

Description: Hails Hits have caused dents in roof & or sheet metal sheeting that can affect the structural integrity of the material depending on the size, location, and severity of the dent.

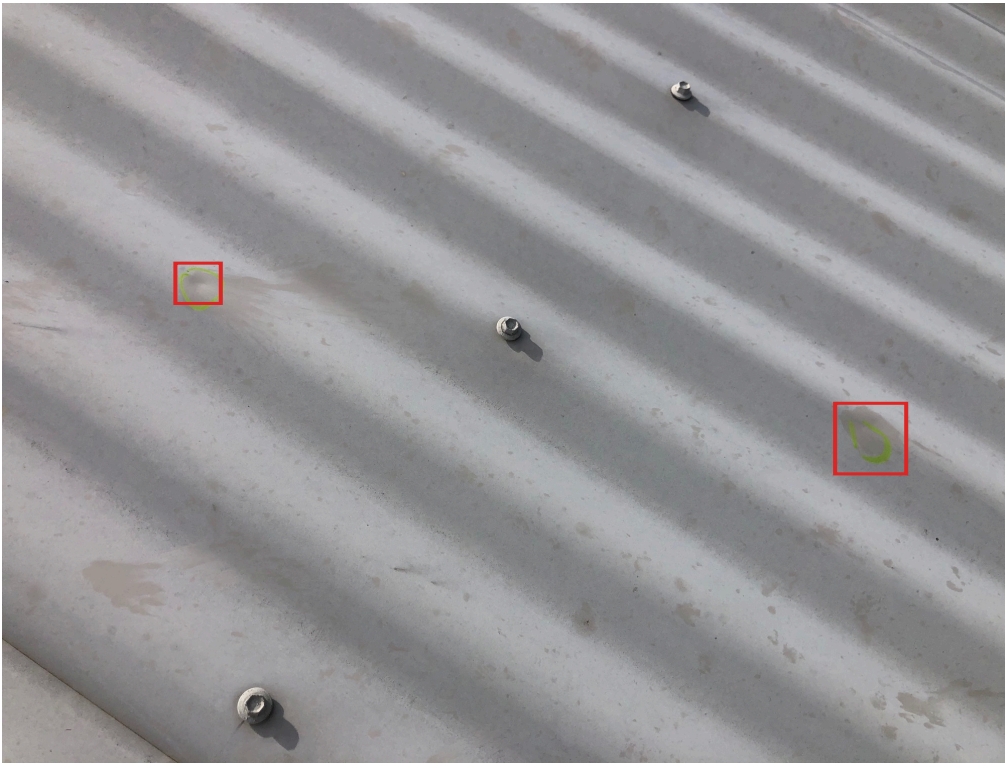
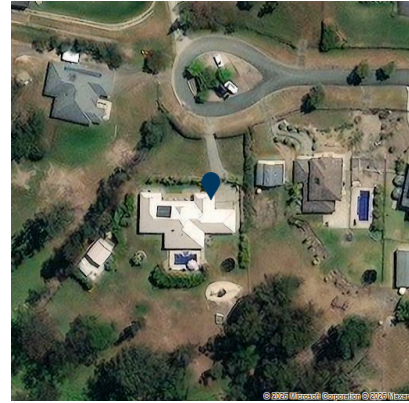
Lat: -27.7443778
 Lon: 152.9176944

● Hail Hit 2

● Hail Hit

insurable

Description: Hails Hits have caused dents in roof & or sheet metal sheeting that can affect the structural integrity of the material depending on the size, location, and severity of the dent.

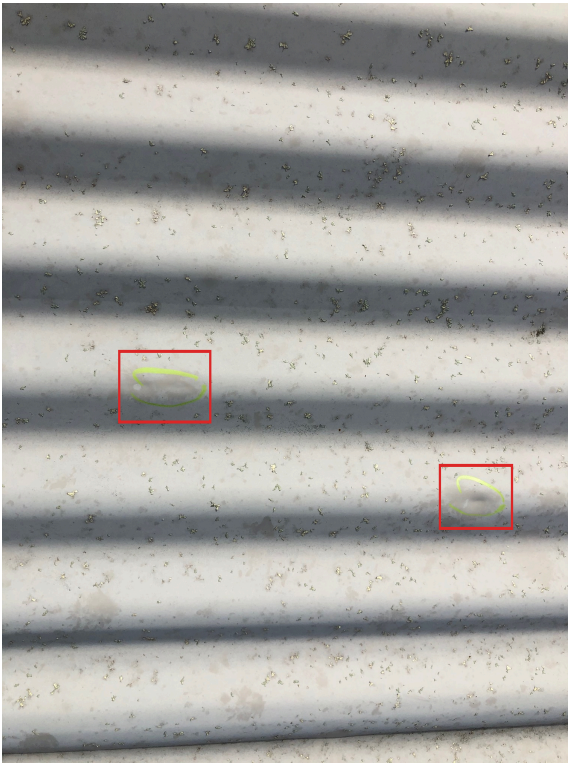
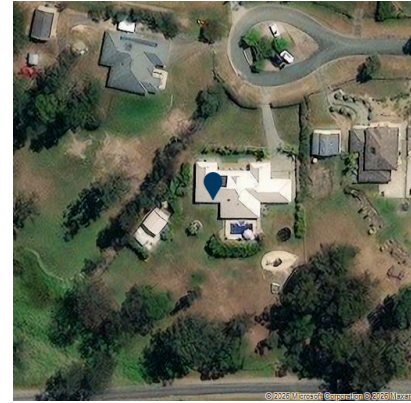
Lat: -27.7444694
Lon: 152.9175111

Hail Hit 2

Hail Hit

insurable

Description: Hails Hits have caused dents in roof & or sheet metal sheeting that can affect the structural integrity of the material depending on the size, location, and severity of the dent.
