**28 Goldfinch Ct,
Greenbank QLD 4124,
Australia**

Roof Information - Default - Main Roof

Damage Assessment - Default - Main Roof

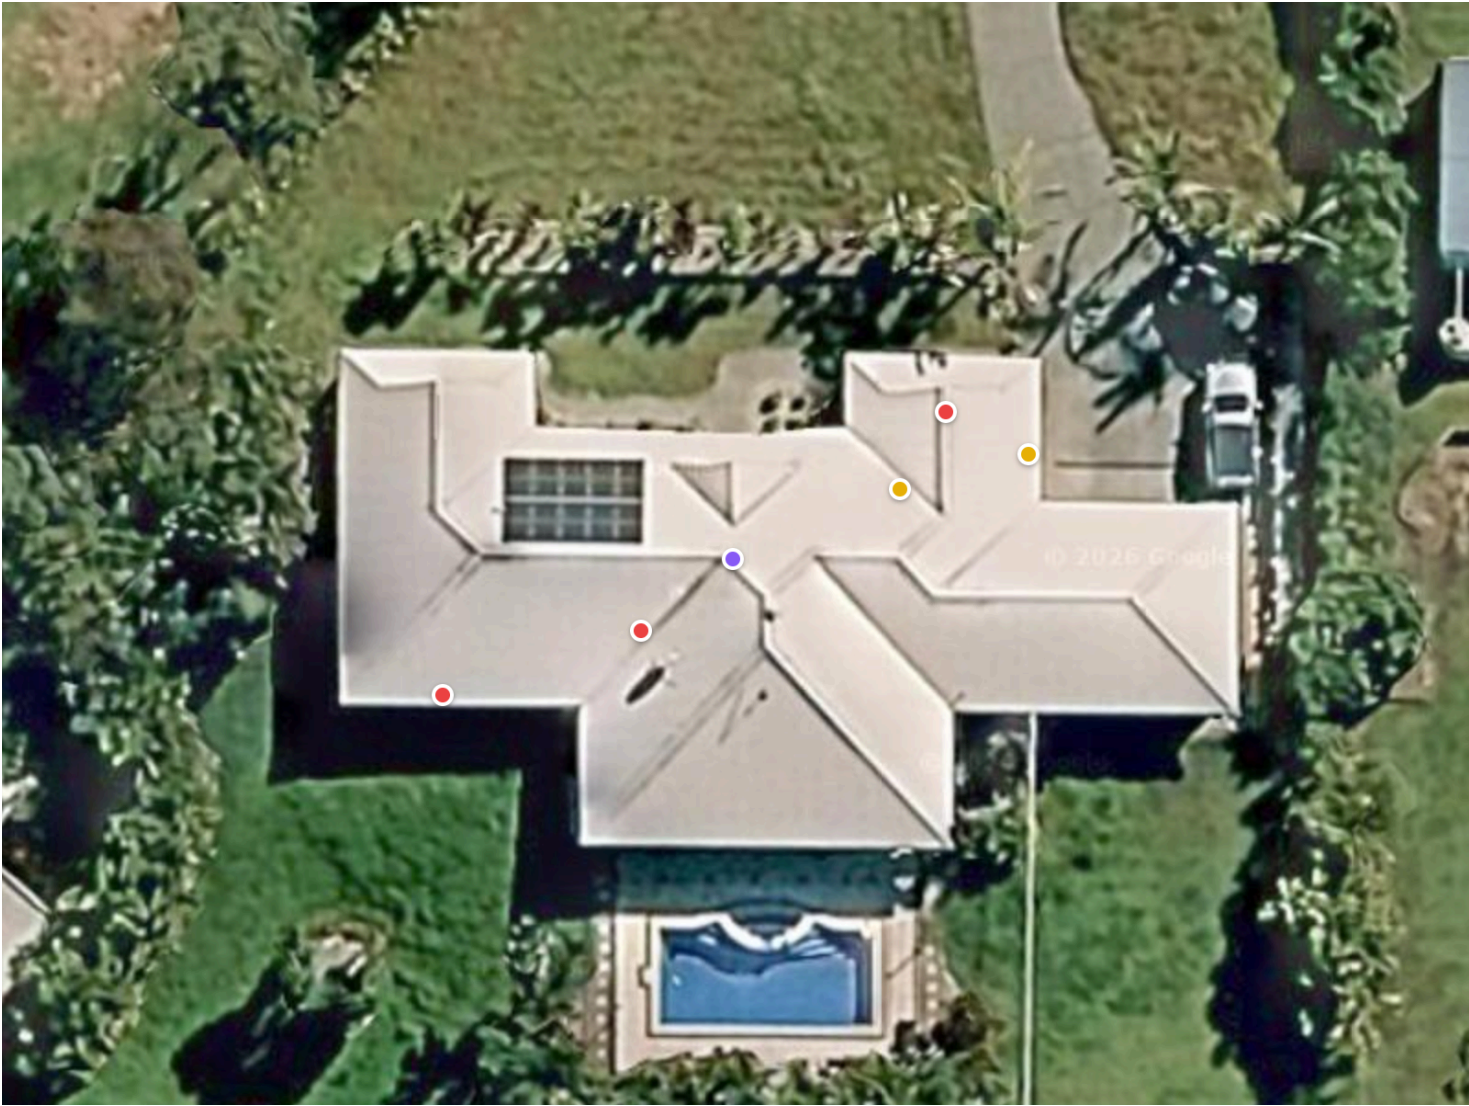
Main Roof

Estimated Damage	26–50%
Other Internal Damage?	None
Cause Of Damage	Hail Storm
Urgent Repairs Required	None

Replace sheet metal

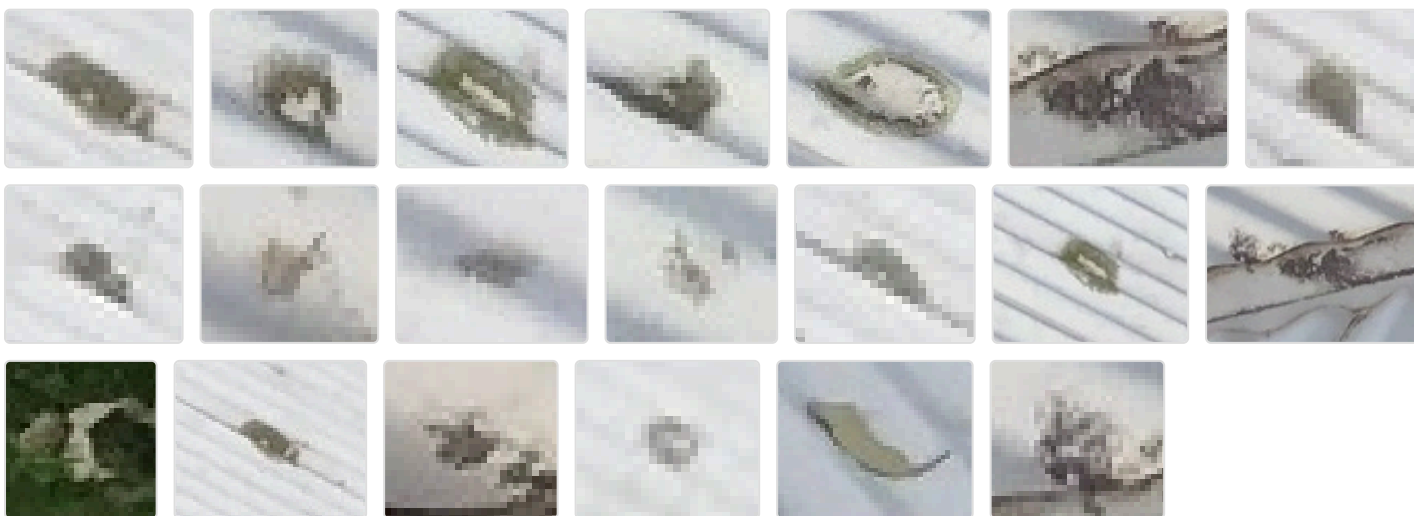
● **Hail Hit**

insurable

Description: Hails Hits have caused dents in roof & or sheet metal sheeting that can affect the structural integrity of the material depending on the size, location, and severity of the dent.
